MAMMOMAT 1000 / 3000

Replacement of parts

Connector X8 on filament cable,
AMP-plug crimping kit

Print No.: SPB7-230.841.02.01.02

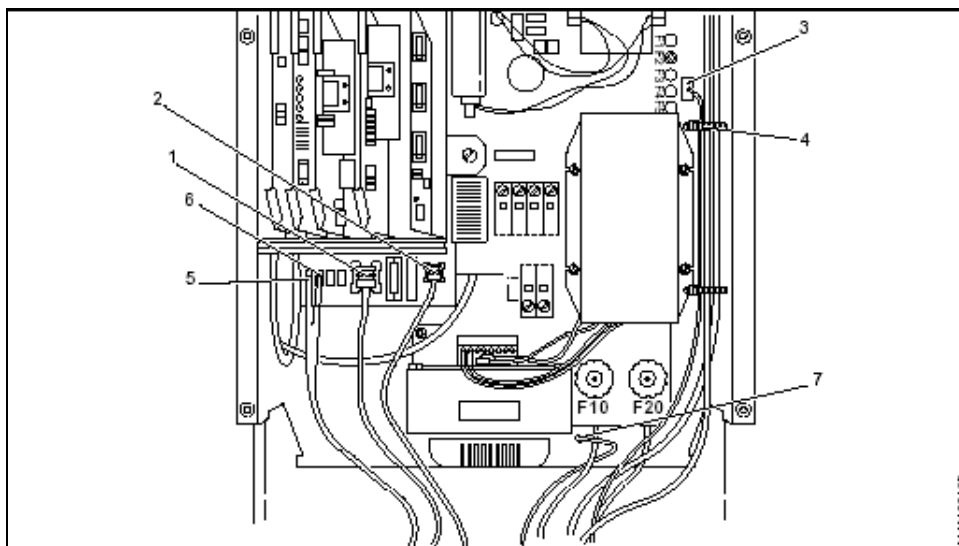
Fig. 1 Generator

- 1) Get access to the connector X8 No: 2 in Figure 1) on the backplane D700 of the generator.

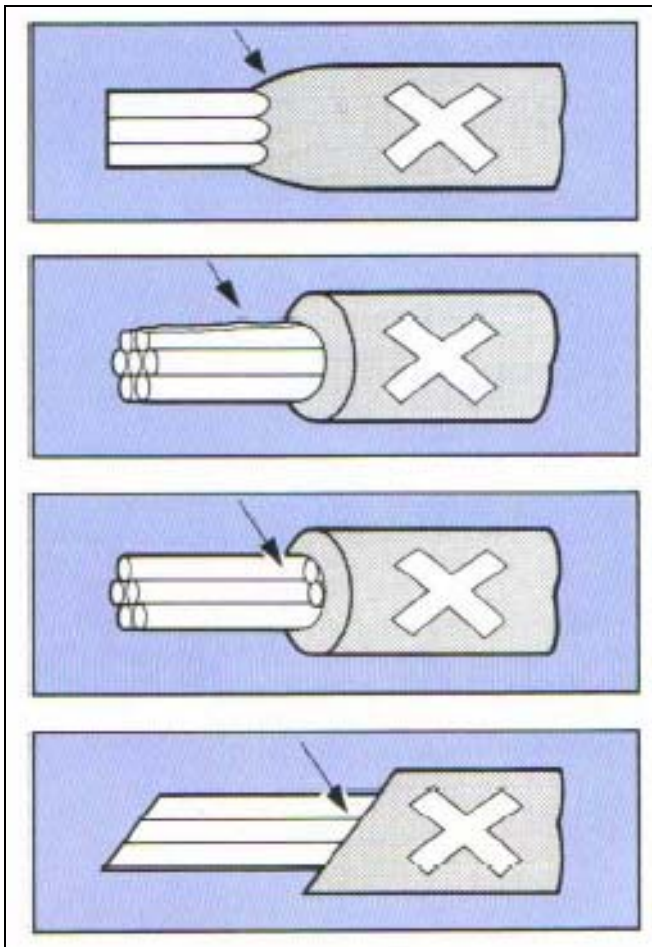
Fig. 2

Incorrect: Stripping blades are too far apart, insulation is torn, not clearly cut,
 Stripping blades are too close together, strands are scrapped or even missing;
 Stripping blades are too close together, strands are cut away;
 Stripping blades are out of alignment;

7) Prepare the wires for new crimping;

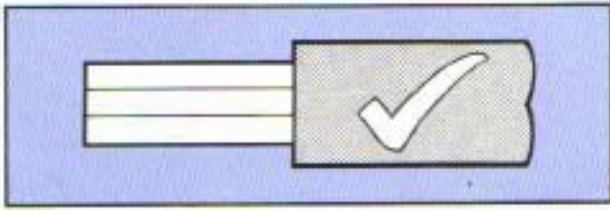
Fig. 3

Correct, this is a good strip:

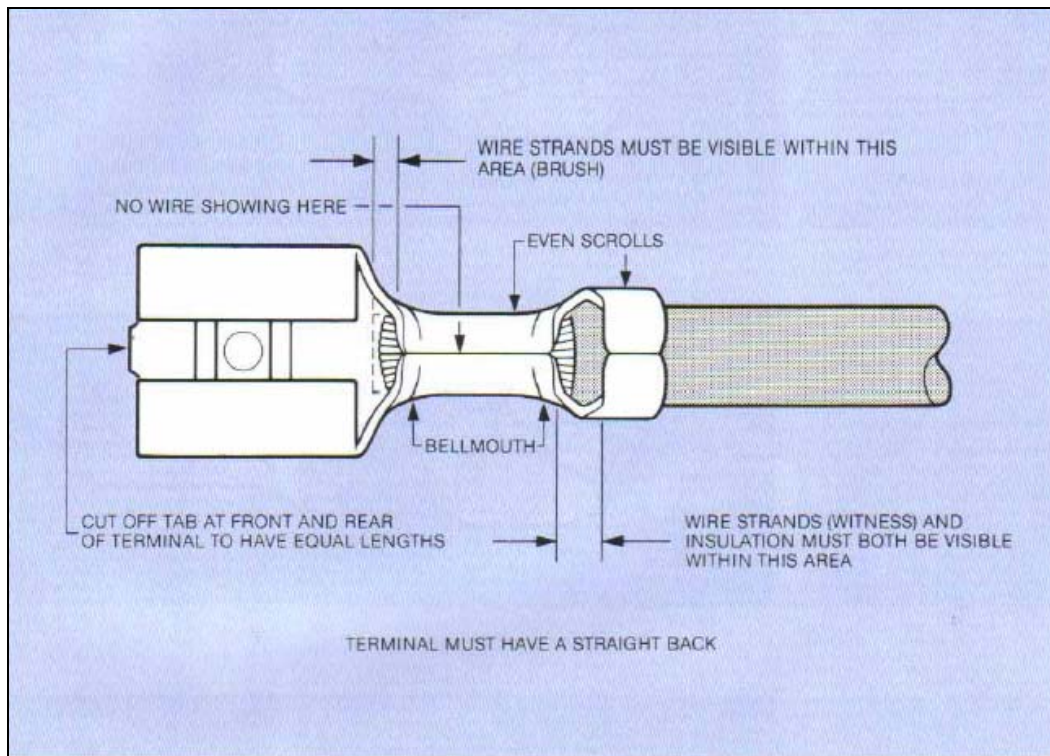
Fig. 4

- 8) Position the prepared wires correctly in the supplied crimping tool and press until automatically released,
- 9) Inspect the crimping according to following picture (note: the terminal in the picture is slightly different than the pin supplied);
